Wallsburg Coordinated Resource Management Plan

in support of the
Coordinated Resource Management and Planning Process

Wasatch Conservation District

February 7, 2012

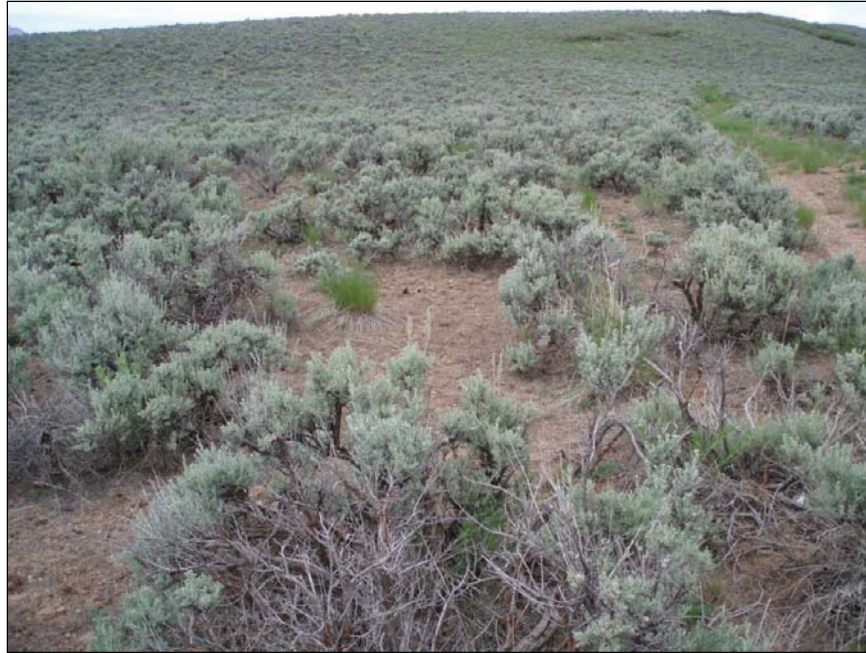
The land cover in the watershed can be generally described as dominated by three classifications: forestland in the upper reaches, sagebrush and shrublands in the mid-elevations of the watershed, and agriculture in the lowlands of the watershed. Table 4-2 shows the percentages of land cover type for the watershed; these are illustrated in Figure 4-4 (NRCS 2010a).
